- - [2000 Rodeo 4WD LS transmission leak](#)

2000 Rodeo 4WD LS transmission leak

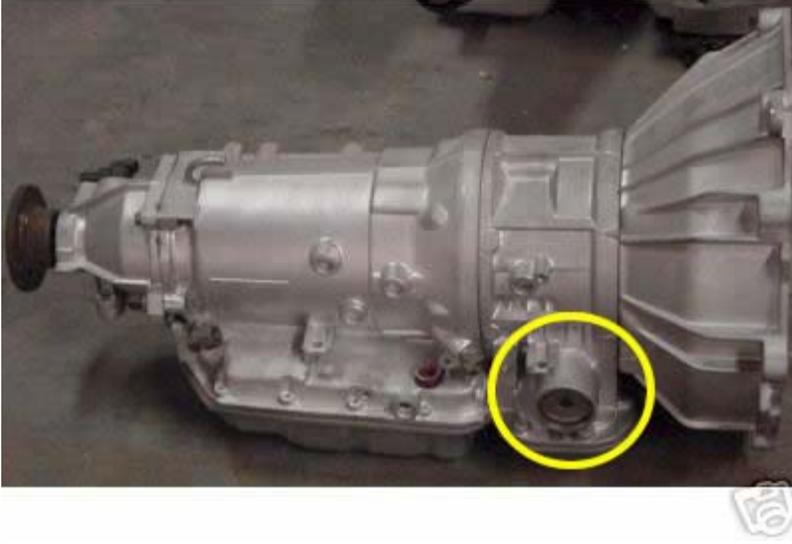
3-4 Accumulator Piston

Disassembled View

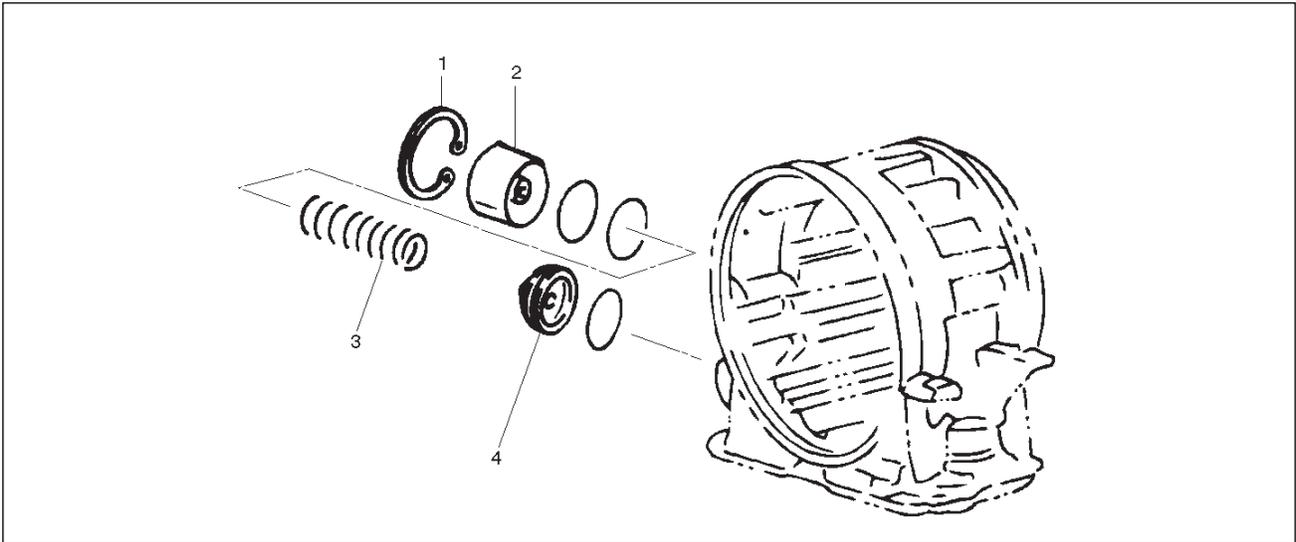
244RS005

Disassembly

1. Install the 5-8840-2277-1 (J-38559-A) cover compressor on adapter case.
 - Compress piston cover then remove snap ring.
